# **EVRAZ**

### **Supplemental Conditions Survey**

August 5, 2019

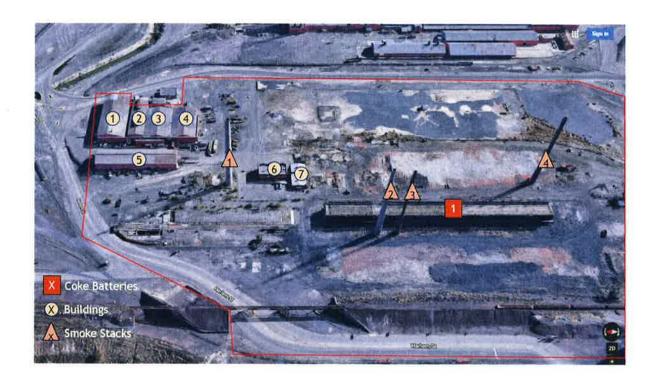
Above is an aerial picture of the Conditions Survey Area. A series of structures assessed and inventoried as part of this work have been labeled on this picture with either a square, circle or triangle to differentiate its type. Within the label is a number identifying the specific structure for reference in the information that follows.
